Case Presentation and Initial Management

Ajjekey, a 3-year-old Domestic Shorthair, presented to our emergency service following a fall from the fourth floor, which resulted in thoracic and pelvic injuries.

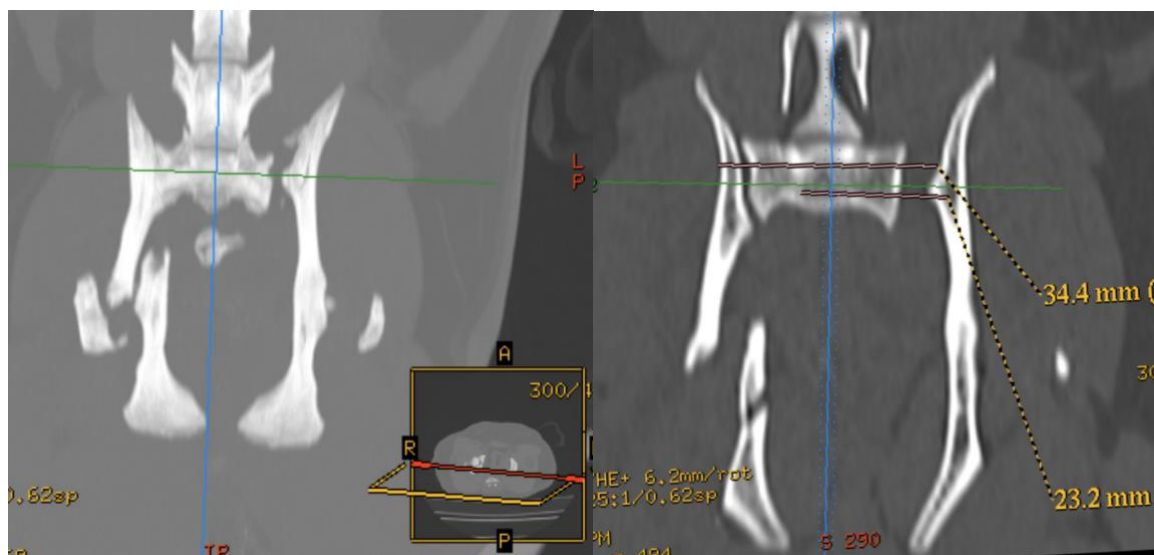
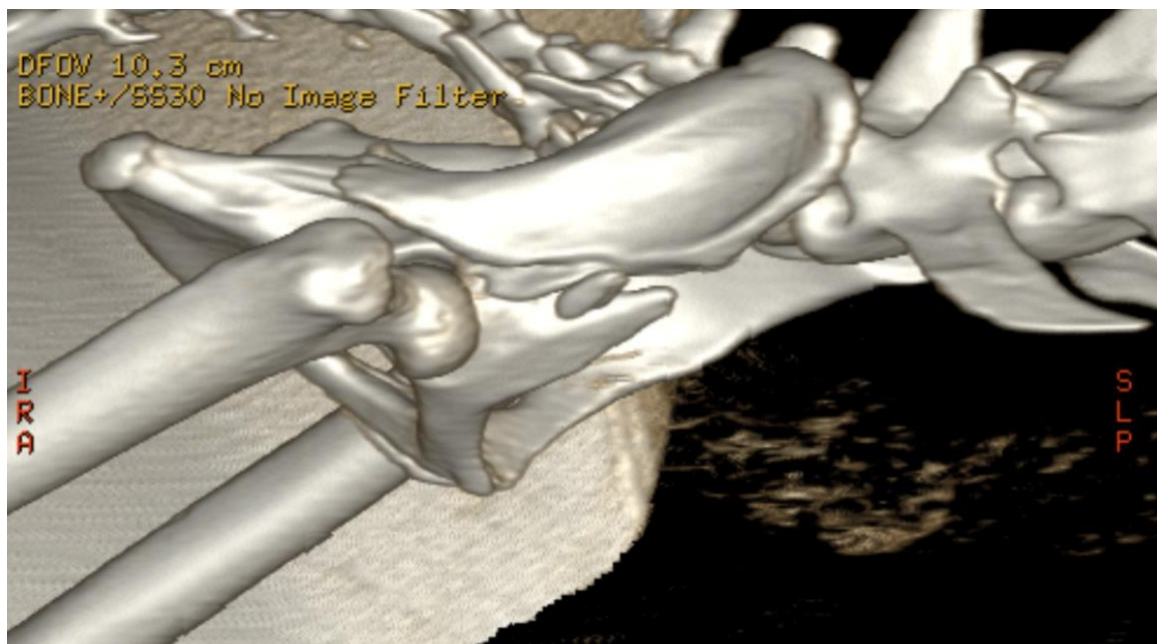
Before Repair CT images of the Fracture Pelvic Bone

The next day, a CT scan was performed to evaluate the extent of the pelvic injuries. The imaging revealed a comminuted fracture of the right ilium.

CT proved invaluable for surgical planning, as the fracture was located quite caudally, raising the possibility of extension into the acetabulum—a region challenging to evaluate with radiographs. Reconstruction of the acetabular medial wall or dorsal rim, if required, would significantly increase the complexity of the surgery and alter the approach.

CT also allowed us to determine the optimal placement of bone screws for stabilisation. While radiographs can depict fractures, long transverse fractures like these can make precise implant positioning challenging.

Fortunately, Ajjekay's right pelvic fracture did not involve the joint, which was favourable.

On the left side, however, imaging showed a sacral wing fracture with ilium displacement. Additionally, a caudal tail fracture or displacement was observed.

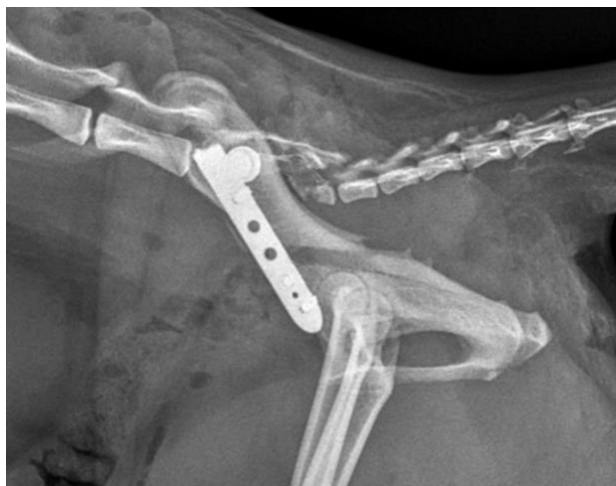
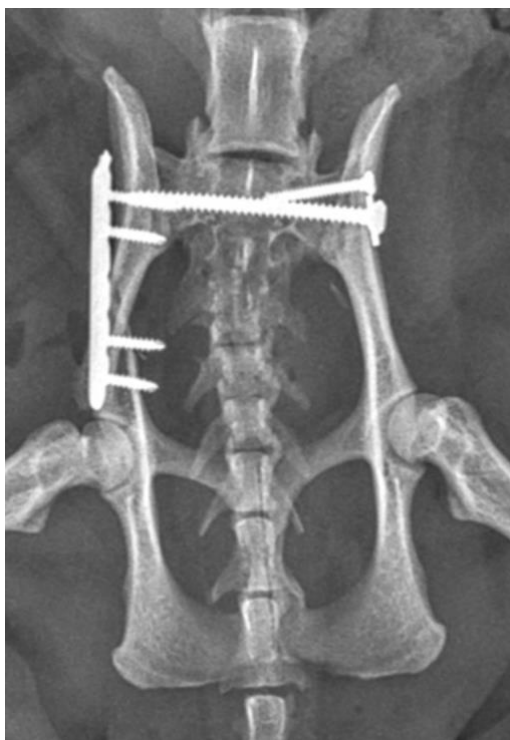
Radiograph Post Pelvic Fracture Repair

We first stabilised the left sacroiliac area to achieve a relatively anatomic reduction, indirectly aligning the right iliac fracture. Using fluoroscopy, we placed a trans-sacral screw with a washer and added a smaller anti-rotational screw into the left iliac wing.

Our focus on the right side was less on achieving anatomic alignment and more on ensuring stability due to its role in weight-bearing. We employed a locking plate with two screws placed cranially and two caudally. During the procedure, we confirmed adequate pelvic canal width via rectal examination. Given the lack of dorsal bone over the acetabulum, the plate was positioned ventrally to optimise its purchase. Preoperative CT confirmed an intact dorsal acetabular bone.

AjjeKay's recovery was excellent. There were no primary neurological injuries; we could reduce and stabilise the fragments without further injury. Anal tone and urination remained normal, and within a short period, AjjeKay was able to ambulate comfortably with good function in the hind limbs. This outcome was particularly gratifying, as pelvic trauma cases can be challenging.
